Contract #: 04-0120F4Cty: SF/ALA Rte: 80 PM: 13.2/13.9File #: 69.28**WELDING INSPECTION REPORT****Resident Engineer:**Siegenthaler, Peter**Address:** 333 Burma Road**City:** Oakland, CA 94607**Report No:** WIR-018556**Date Inspected:** 07-Dec-2010**Project Name:** SAS Superstructure**OSM Arrival Time:** 700**Prime Contractor:** American Bridge/Fluor Enterprises, a JV**OSM Departure Time:** 1900**Contractor:** Zhenhua Port Machinery Company, Ltd (ZPMC), Changxing Island **Location:** Shanghai, China**CWI Name:** Xu Xian Ping**CWI Present:** Yes No**Inspected CWI report:** Yes No N/A**Rod Oven in Use:** Yes No N/A**Electrode to specification:** Yes No N/A**Weld Procedures Followed:** Yes No N/A**Qualified Welders:** Yes No N/A**Verified Joint Fit-up:** Yes No N/A**Approved Drawings:** Yes No N/A**Approved WPS:** Yes No N/A**Delayed / Cancelled:** Yes No N/A**Bridge No:** 34-0006**Component:** Orthotropic Box Girder (OBG)**Summary of Items Observed:**

WELDING INSPECTION REPORT

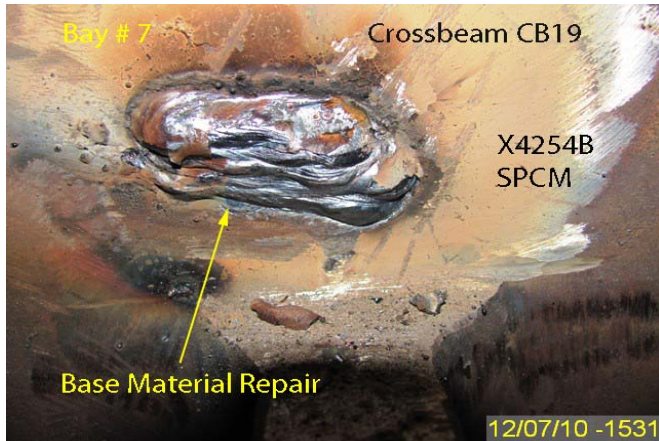
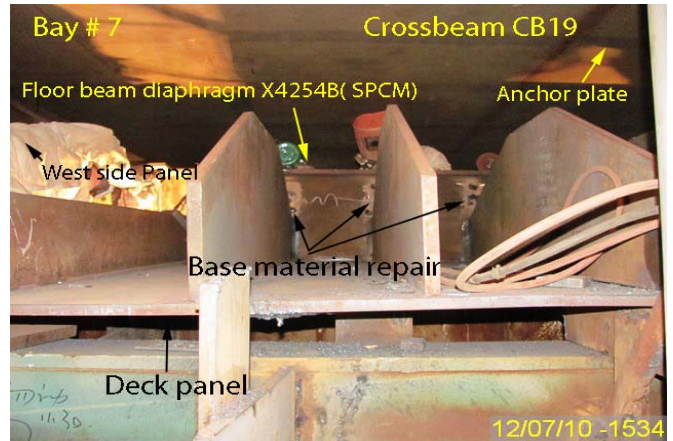
During the Quality Assurance (QA) random in-process visual inspection of Orthotropic Box Girder (OBG) Crossbeam CB19, this QA inspector discovered the following issue. Base metal repairs being performed without prior approval of the Engineer. Repairs were being performed in runoff tab removal areas on the Floor beam diaphragm web plate. Floor beam diaphragm is identified as FB3246. Web plate is identified as X4254B (SPCM).

The material is A709 Grade 345 Seismic Performance Critical Member (SPCM). This QA notified ZPMC QC identified as Mr. Xu hai yang of this issue and that an incident report would be generated. For further information, please see the attached pictures below.
